Clean Air Act Full Compliance Evaluation Inspection Report

Central Washington University
Ellensburg, Washington

Inspection Dates: May 17-18, 2022

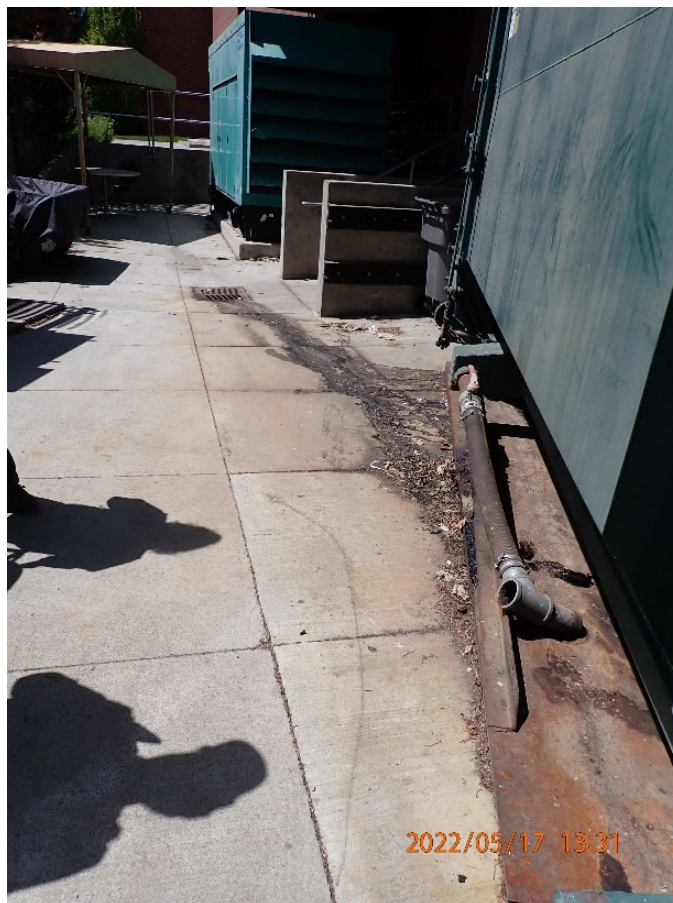
The emergency generator G9 for the Student Union Building is outdoors, at the back loading dock and trash compactor on the south side of the building. It is on a cement pad and is covered with a roof. The stack is horizontal and is also covered by the roof. We waited for an operator to come by and unlock the door to the engine housing. While we were waiting, we noticed a dark, oily stain on the ground coming from the trash compactor at this location, leading to a storm drain. A drain valve and flexible hose from the trash compactor was in the open position. The storm drain was labeled: “No Dumping. Drains to River” with a graphic of a fish stenciled there. (See Figures 1 and 2, below.)

Figure 1: Student Union Trash Compactor (at right), with oily stain leading to storm drain. Generator G9 in the background.

Note that the fuel storage tank for the emergency generator is housed with the engine unit. A fuel leak in this area would very likely flow to the storm drain shown in Figures 1 and 2, below. Records reviewed for this inspection show this generator had the greatest amount of use of all generators on campus (2021), and significant maintenance problems, including a battery that blew up, a leaking water pump and leaking heater. (See Records Review Section, below.)

- At the Student Union Building we saw a compactor/dumpster with drainage flowing to a storm drain. The storm drain is labeled "No Dumping, Drains to River." There is also a fuel storage tank with the generator in that location which has the potential to get into the drain if there's a fuel leak.

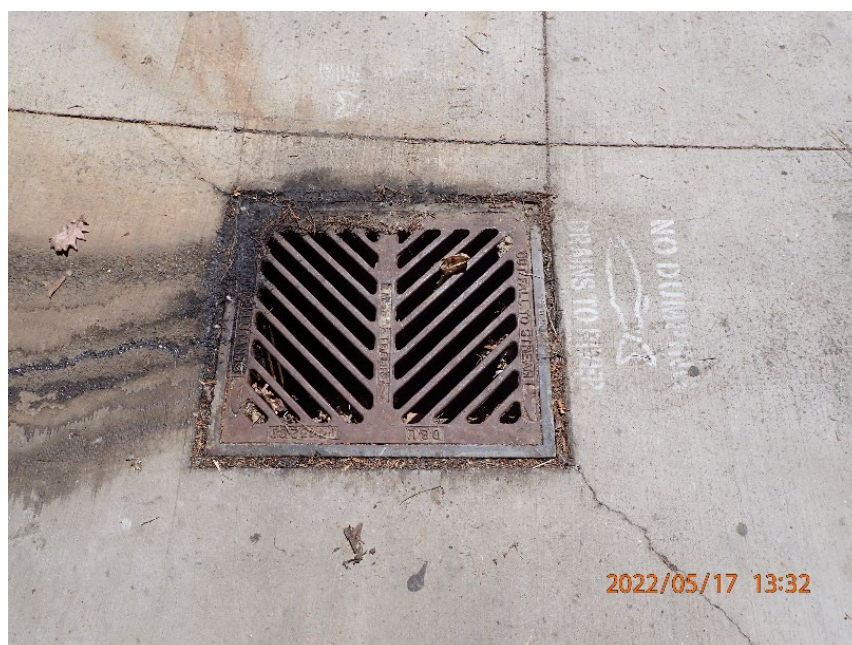
Figure 2: Student Union Storm Drain, labeled "No Dumping, Drains to River" Oily fluid stains are seen going to this drain.
